Salt Fork Stream Restoration Investigation

CEE 498 FM

Jonathan Czuba

August 27, 2007

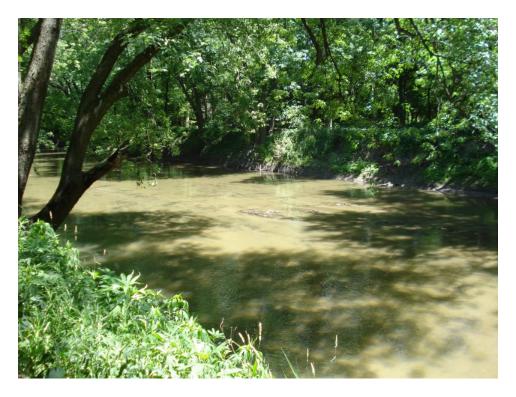
Figure 3: Salt Fork at the Sidney Gage (Photo Courtesy of Davide Motta)

two of the dredging is scheduled for the 2007-2008 time frame. If this dredging is allowed to occur it will destroy riparian habitat similar to what exists at the Sidney gage (03337848) (Figure 3). The extent of the phase two dredging will extend from the St. Joseph gage to a point not far upstream of the Sidney gage.

Temperature data was collected at two sites on the Salt Fork. Temperature data collected at the St. Joseph gage was provided by the USGS. Temperature data at Sidney was collected using a YSI water quality probe installed by Art Schmidt. The temperature data collected at the two sites is shown in Figure 21. At both sites the temperature peaks in the late afternoon to early evening and is lowest in the morning. The daily fluctuations in water temperature reflect diurnal patterns. The water temperature at the St. Joseph gage exhibited greater fluctuations than at the Sidney gage. When the reach upstream of the St. Joseph gage was dredged the vegetation along the stream corridor was removed causing the stream to become more sensitive to temperature variations (Figure 2). The corridor just upstream and along the Sidney gage has adequate vegetation to act as a water temperature buffer (Figure 3).

In order to protect riparian habitat, a stream restoration project should be implemented that does not require maintenance dredging. This would save the riparian trees and maintain the water temperature buffering affect they have on the Salt Fork.

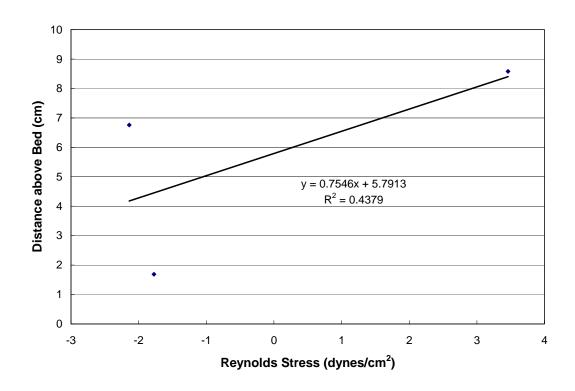
Figure 12: Extrapolation of Reynolds Stress to the Bed in the Middle of the Channel

Bed shear stress was used as an indicator for bed stability. The bed shear stress was calculated based on the velocity data. One method employed was the extrapolation of Reynolds stresses to the bed (Holmes 2007). Reynolds stresses were computed from the covariance between x and z velocity fluctuations, which WinADV produced in a statistical summary table, and the density of water computed at a temperature of 28°C, which was recorded in the field notes. A value for bed shear stress was extrapolated from this data (Figure 11). For the probe near the right bank a bed shear stress of 3.2 dynes/cm² was calculated. For the probe in the middle of the channel, based on the data, a negative bed shear stress was calculated (Figure 12). This physically did not make

sense. A further investigation into probe 349, which was in the middle of the channel, indicated that this method for computing Reynolds stress from the velocity fluctuations was inappropriate.

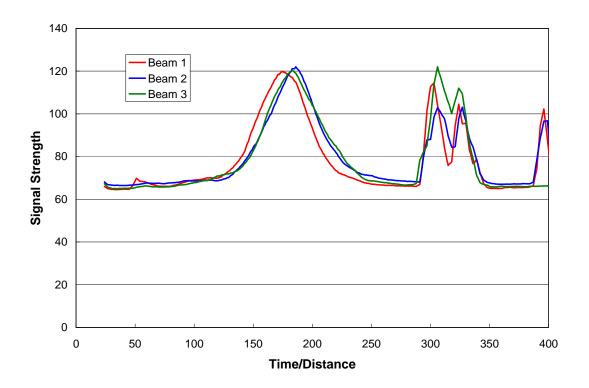
Figure 13: Probe Check for ADV 349

A further investigation into Nortek ADVs, 349 and 388, was performed to determine if there were any problems with the beams. The probes were held in place by clamps and suspended in a 5-gallon bucket of water. Data was collected for two minutes using the Check probes diagnostic (NDVCHECK) in CollectV. These samples were averaged together to create Time/Distance vs. Signal Strength graphs. These plots show multiple peaks. The first peak is due to transmit noise. The second peak is due to the sampling volume. The third peak is due to the bottom echo. For diagnostic purposes, the second peak is the peak of interest. For the 10 cm probe (349) this peak is located at approximately 200 units and for the 5 cm probe (388) this peak is located at approximately 100 units. The Time/Distance vs. Signal Strength graphs for probes 349 and 388 are shown in Figure 13 and Figure 14 respectively. For probe 349 the sampling volume peak for beam 1 is offset (horizontally) approximately 10 units from the peaks of the other beams.

According to Nortek, the receiver arm for beam 1 is bent. Therefore the velocity data obtained by probe 349 is noisy, more than what could be credited to turbulence alone, and can not be used to measure turbulence parameters. Probe 388 did not show any significant problems. Additional

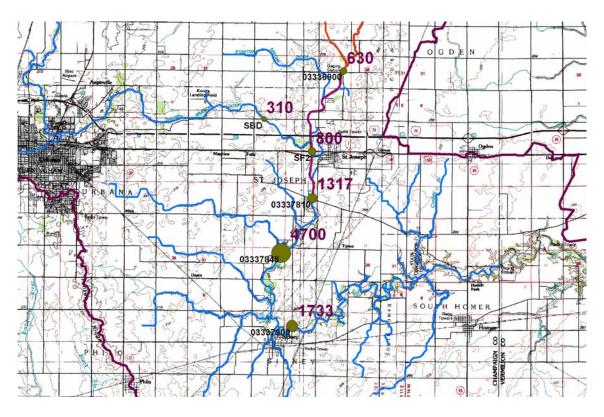
Figure 20: Bacteria Impairment

The Illinois Environmental Protection Agency does not have a water quality standard for E. coli, only fecal coliforms (IEPA 2006). The maximum E. coli level for recreational waters based on U.S. Environmental Protection Agency guidelines is 235 colonies/100 mL (IDPH 2007). According to the data collected, all sampled sites exceed this standard. The problem with the data collected was that only one sample was taken at each site instead of what should have been five samples at each site then reporting the median value. In addition, some of the samples taken were dipped into the water multiple times which could have contaminated the sample or resulted in higher than normal bacteria levels. The sample taken at the Sidney gage was resampled more than any other samples taken and had the highest bacteria count of any of the sampled sites. This data should be used with caution. There were not enough data samples to say anything of value. But assuming the data was reasonable, or at least the values relative to one another, it appears that the St. Joseph WWTP located below SF2 was not the cause of the high counts at the Sidney gage. The site at 03337810 should have a higher count if the St. Joseph WWTP was responsible for the elevated counts. The elevated bacteria counts could be from septic tank leachate. It is difficult to say what caused the elevated counts at the Sidney gage, more accurate data and more detailed data along this reach would be necessary to identify the probable source.

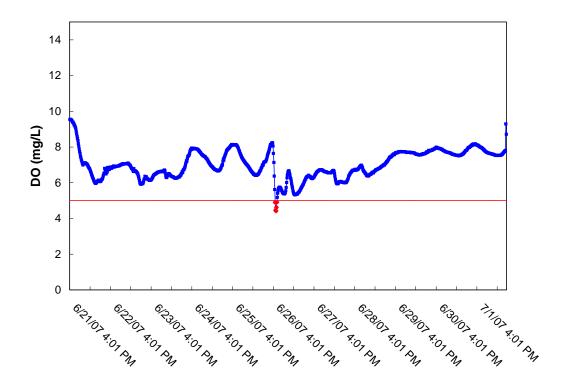
Figure 23: Dissolved Oxygen in the Salt Fork at the Sidney Gage

The water quality standard for dissolved oxygen in the Salt Fork is that it shall not be less than 6.0 mg/L during at least 16 hours of any 24 hour period, nor less than 5.0 mg/L at any time (IEPA 2006). The period of time when the YSI water quality probe collected dissolved oxygen data, the water quality standard for dissolved oxygen was violated (Figure 23).

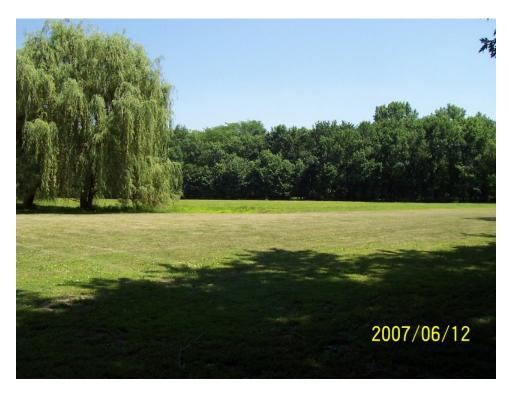
Figure 29: Floodplain at the Sidney Gage (Photo Courtesy of Bob Holmes)

According to the landowner, Bob Holmes, the previous land owner attempted to construct a pond at this site in the floodplain of the Salt Fork (Figure 29). During a flood event the pond would fill up with water first and then the floodplain would become inundated, indicating that the pond was hydraulically connected to the stream. When the water receded the pond emptied within a few days. He also noted that the floodplain would become inundated a few times per year. The pond that was attempted by the previous landowner was fairly shallow and if it were dug deeper or lined with clay, it may have been more effective. In order to determine the feasibility of a constructed wetland, a Geoprobe was used to collect a soil core and to install a shallow groundwater well in the floodplain at the Sidney gage (Figure 30). The coring and installation of the well was performed following standard USGS guidelines (Lapham et al. 1997).

The pond attempted in the floodplain at the Sidney gage by the previous land owner was not dug deep enough and within soil horizons that were not conducive to retaining water. A wetland/pond is feasible in the floodplain at the Sidney gage if designed properly. Since the groundwater in the floodplain is hydraulically connected to the Salt Fork, a wetland would only need to be dug deep enough to intersect the groundwater level. Based on the stage data in the Salt Fork and the flow duration curve, it is possible to estimate the frequency a certain groundwater elevation will attain. Multiple terraces could be constructed in the floodplain at different elevations to match certain frequencies of saturation. Wetland plants could then be chosen based on the frequency of saturation. If an area was excavated deep enough, to the top of the confining layer, water would remain in this excavation continually, unless the Salt Fork dries up. This would create a pond in the floodplain. The water level in the pond would fluctuate with the water surface elevation of the Salt Fork. The water level fluctuations in the pond could be dampened by lining part of the pond with clay or some other semi-impermeable material. If the pond were lined, more than likely the semi-impermeable layer would have to be overtopped by the groundwater in order for the pond to fill up.

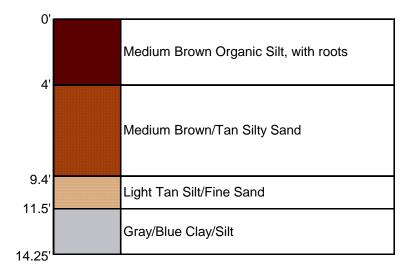
Figure 32: Soil Profile from the Sidney Gage

The soil core was collected by Pat Mills and Jon Czuba. Gary Johnson of the USGS was on hand assisting. The soil core collected is shown in Figure 31. The soil core was collected in four sections. The sections are in order from shallowest to deepest from right to left with the top of the section at the top of the picture. Each section should theoretically have four feet of soil; this is only true for the first section. The second and third sections of the soil core appear to have lost soil due to compression during coring. The fourth section of the soil core was not cored for the full four feet because the confining layer was reached. An interpretation of the soil column in the floodplain at the Sidney gage is shown in Figure 32. For the most part, the column shown follows the field notes taken by Pat Mills. Near the bottom of the third section gray "gravel" was encountered. This "gravel" is shown at the bottom of Figure 31 in between section three and four. This gravel is strikingly similar to the clay in section four. Pat's notes indicate that the first foot of section four is tan silty sand which it appears to be in Figure 31. During a cursory review of the top of section four when opened, beneath a thin layer of silty sand was the clay which connected the bottom of section three to the rest of section four. When section three was removed from the coring hole, some of the wet silty sand slumped down to the bottom of the hole. Upon driving section four into the coring hole, the wet silty sand that slumped down was smeared on the outer portion of the top of section four. The interpretation of the soil profile in Figure 32 corrects this inconsistency. The other sections were not verified with the field notes because the soil core was discarded sooner than expected.

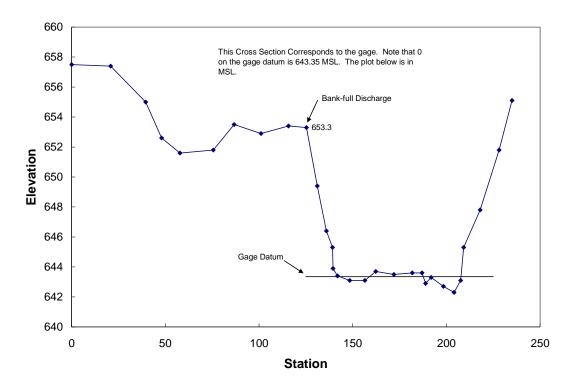
Figure 33: Channel Cross Section at the Sidney Gage with Gage Datum

The bank-full discharge of the Salt Fork at the Sidney gage is 2000 cfs. This discharge corresponds to a stage of 10 ft (Figure 4) which corresponds to an elevation of 653.3 ft (Figure 33). The channel cross section verifies that this is an accurate estimate of the bank-full discharge. The exceedence probability of the bank-full discharge is around 1.5% (Figure 6). This means that the Salt Fork will inundate its floodplain at the Sidney gage a few times per year which verifies Bob Holmes' testimony.
